Roof on WWTP Building

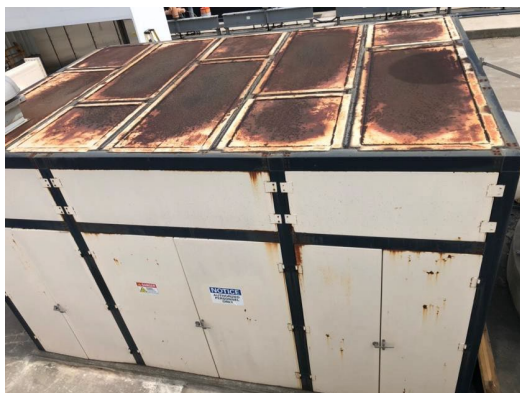
This WWTP was seeing extensive corrosion with their infrastructure. The corrosion was so advanced that it was causing the roof to leak.

Abrasive blasting was used to remove the rust. **Maxon CRS** acts as a corrosion retardant system that penetrates the steel, 20+ mils, so it goes in the metal not on the metal.

A viscoelastic sealant was used to seal the joints along with **Viscotag EZ Wrap** to create a flexible surface to stop leaking. To make everything look a pleasing two coats of **Resichem 555 Resinox**. Resinox was spray applied for future corrosion prevention.
