# Airport Taxi Way

### PROBLEM

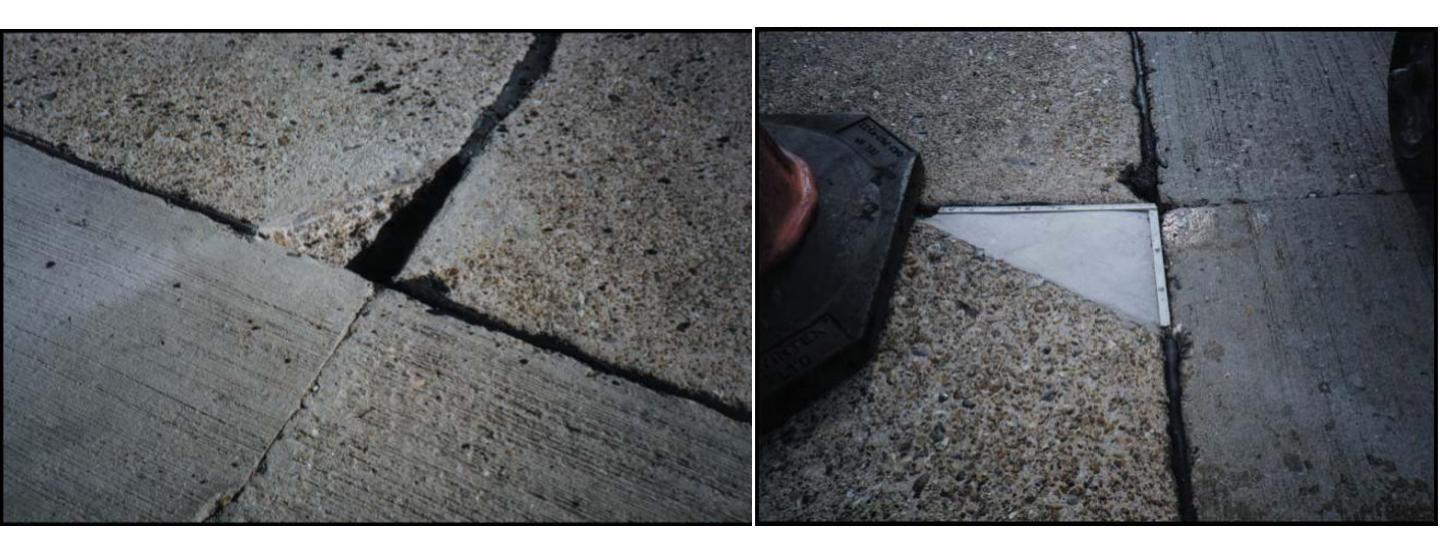
The airport was suffering from the continual breakdown and chipping of the arris edges of the concrete slab on the taxiway where they are jointed. This was a continual problem due to the compressive forces of the aircraft nose wheels and the added problem of extreme weather cycle exposure. Extensive areas needed repair and being one of the busiest airports in the world, the timescale was limited.

Trials using RESICHEM 570 Concrete Patch Repair XF were carried out in the summer and monitored throughout the winter. The surfaces were prepared with scabblers to leave a good edge prior to the application of RESICHEM 570 Concrete Patch Repair XF. The areas for repair were only available for 7 hours throughout the night and all repairs had to be cured to a compressive strength of 20 N/mm. This was achieved by keeping the unmixed product warm prior to application and adding heat to the repaired areas to speed up the cure time. The repairs proved a complete success with the regular flow of aircrafts using the taxiway the following morning.
