Unconventional Solutions, Inc.

Project: Gas Ventilator Refurbishment

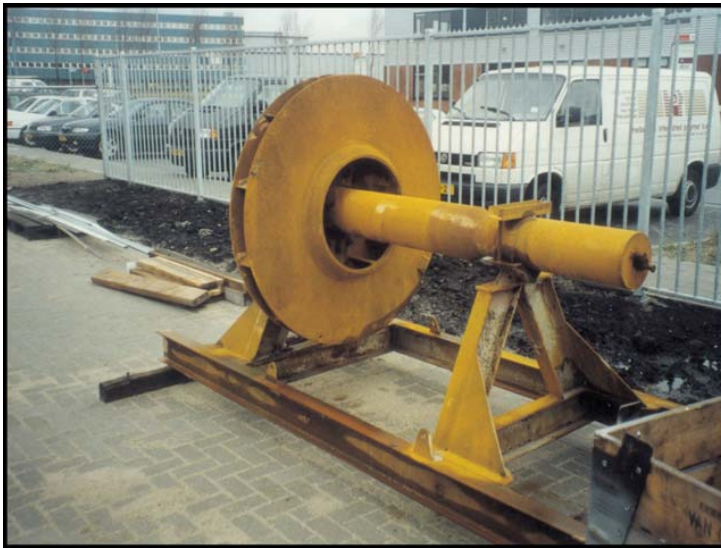
The housing, impeller, and castings of this furnace exhaust gas ventilator at this plant had been earmarked for refurbishment.

They required a high temperature resistance coating, which would withstand wet air at a temperature of 248-302°F.

The internal components of the exhaust gas ventilator were abrasive blast cleaned to a minimum industry standard of NASE Grade 2, ensuring all loose abrasive dust and debris was vacuum cleaned away. **USI Hot Temperature Lining** was then applied.

USI Hot Temperature Lining is a two component, fluid grade, ceramic enhanced epoxy resurfacing compound that has been specially developed for high temperature immersion conditions. This makes it ideal for resurfacing pumps, impellers, valves, tube sheets, water boxes, and heat exchangers.
