Unconventional Solutions, Inc.

Project: Gate Valve Repair

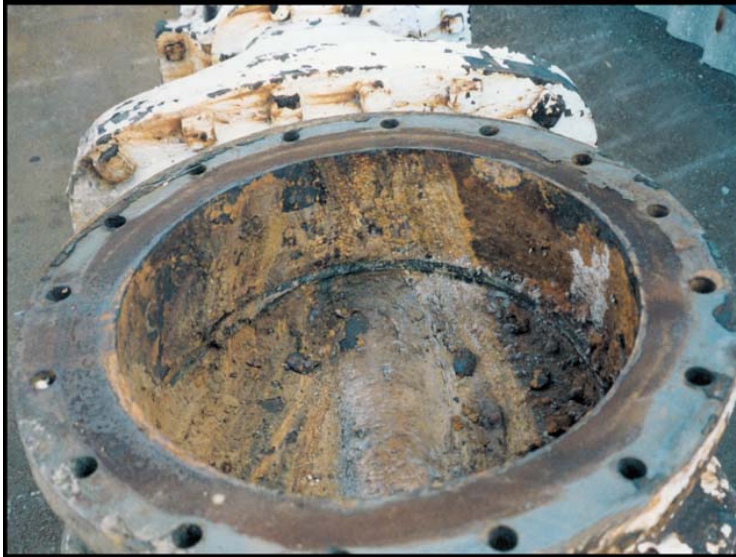
The surfaces of the gate valve shown in this photograph had been subjected to severe erosion and corrosion as a result of the very aggressive operating conditions.

Immediate repairs were required to extend the life of this expensive piece of equipment.

All loose material was scraped away. The surfaces were then blast cleaned to a minimum industry standard of NASE Grade 2. Our multi-purpose ceramic epoxy **USI Ceramic Rebuild** was used to rebuild the internal surfaces of the gate valve, after which **USI Ceramic Lining FG** was applied.

USI Ceramic Lining FG is a solvent-free epoxy coating which provides a smooth, low friction finish as well as optimum levels of physical and mechanical strength, and superior resistance to erosion and corrosion.
