# Unconventional Solutions, Inc.

## Project: Primary Sludge Pump Repair

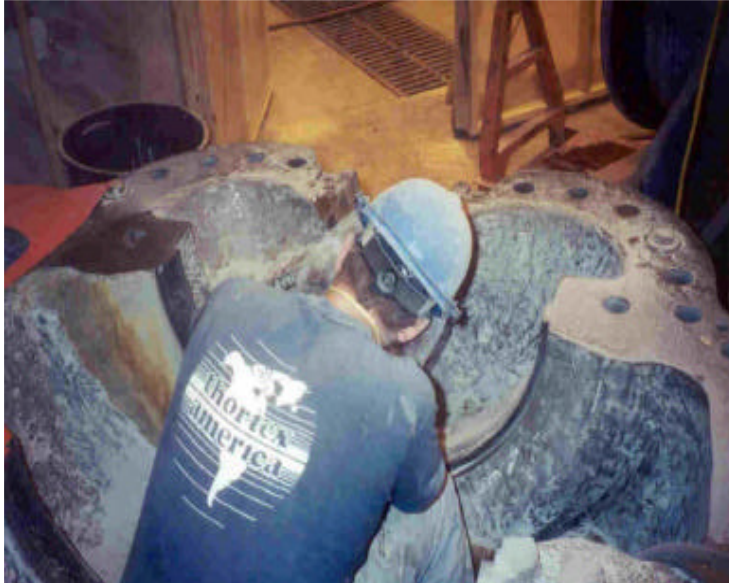
This waste water treatment plant's primary sludge pump wasn't working to full capacity because of years of wear and erosion.

Abrasive blasting was used on the pump housing. Then the pump was rebuilt to its original tolerances using **USI Ceramic Rebuild** and finished with two coats of **USI Ceramic Lining FG**.
