Unconventional Solutions, Inc.

Project: Processing Pump Refurbishment

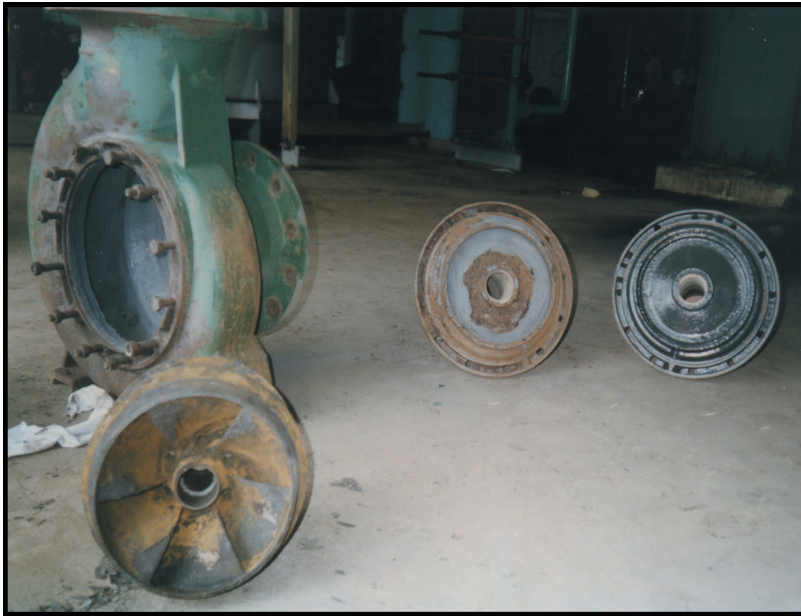
The pumps used by this processing company were in poor condition. The efficiency of their operation was being affected and the pumps required rebuilding or replacing.

The pumps were first blast cleaned and the corroded areas inside the pumps were rebuilt with **USI Ceramic Rebuild**.

Once this had cured, the internal surfaces of the pumps were lined with two coats of **USI Abrasive Surfacer** - a low friction corrosion resistant lining.

In most cases, the external surfaces of the pumps were coated with two coats of **USI Ultimate and Chemical Lining**.

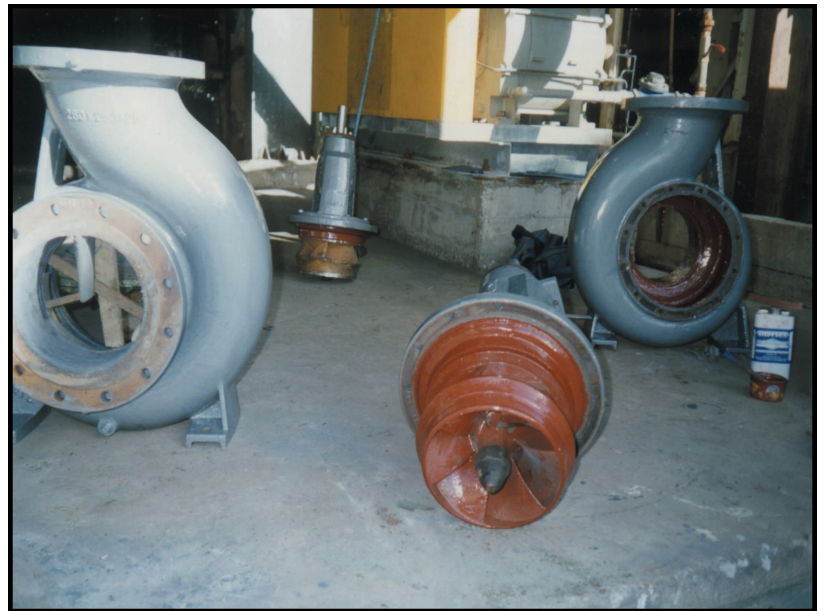
The customer was delighted with the finish and performance, and has adopted this system for all pump refurbishments.
