# Unconventional Solutions, Inc.

## Project: Rotary Lobe Blower Refurbishment

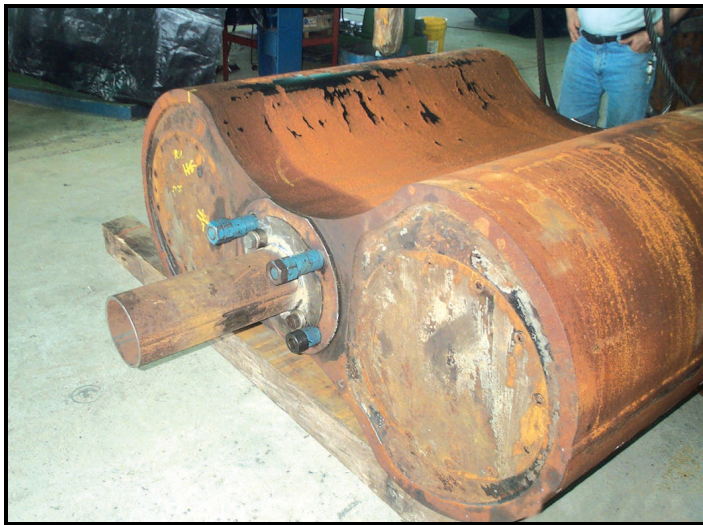
The Process Gas Compressor was disassembled and the casing, rotors, and head plates were found to be severely eroded and corroded.

The rotors were abrasive blasted. All deep areas were filled with **USI Ceramic Rebuild** and leveled to provide a suitable base to rebuild on. Two coats of **USI Ceramic Lining FG** was applied for low friction.

The same procedure was carried out on the head plates. The casing was rebuilt using **USI Metal Repair EG** leveled and finished with one coat of **USI Ceramic Lining FG**.
