Wastewater Treatment Plant Sewage Shaft

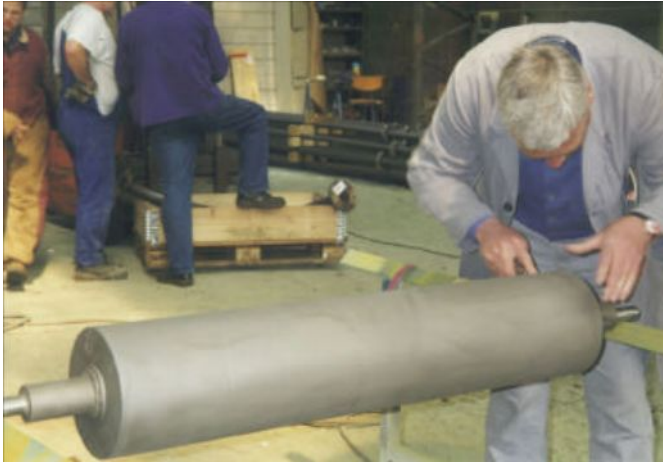
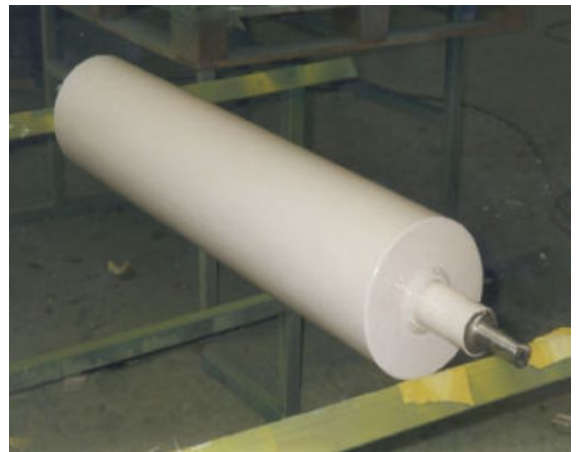
This wastewater treatment plant was having issues with their sewage shafts. The shafts were showing signs of wear and tear.

Surface contamination was removed by abrasive blasting and the shafts were degreased. RESIMETAL 101 Metal Repair Paste was applied to repair the damage and bring the surface back to its original profile. A topcoat of RESICHEM 501 CRSG was then applied. RESIMETAL 101 Metal Repair Paste is a multi-purpose, synthetic repair compound specifically developed for metal repairs requiring good mechanical strength combined with easy machining properties.
