Tunnel Refurbishment

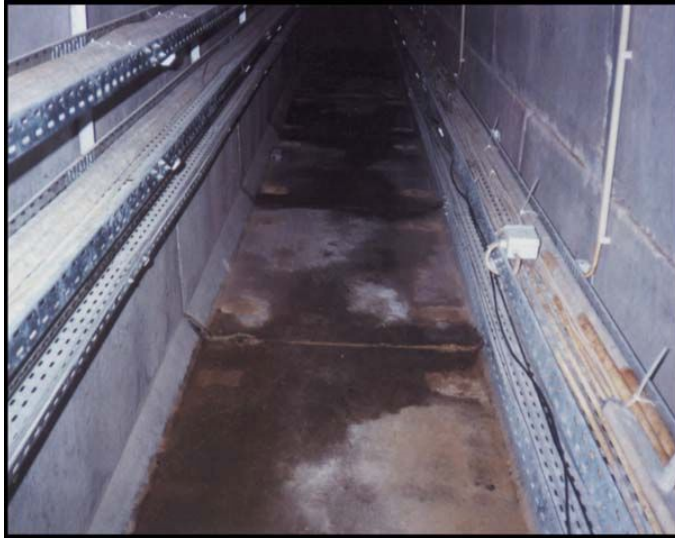
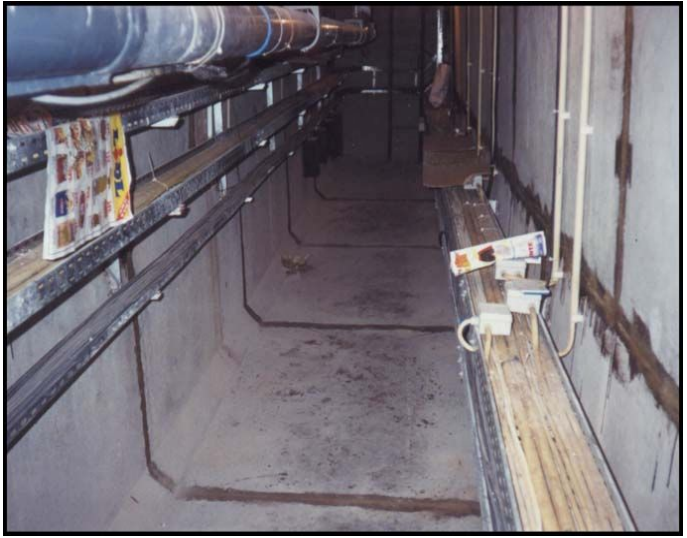
This tunnel carries cables to a large supermarket. It was suffering problems with water ingress and high humidity.

The high levels of humidity within the tunnel itself were affecting the cables and causing major problems within the supermarket itself.

The badly affected areas were treated with Resichem 573 Fastfill Screed Concrete Seal. This was where water penetration was occurring.

All joints were primed and filled with RESICHEM 571 Concrete Repair LW. In total, almost 750 feet of tunnel length were treated, and the application has been a complete success.
