Project: Beverage Power Plant Floor Repair

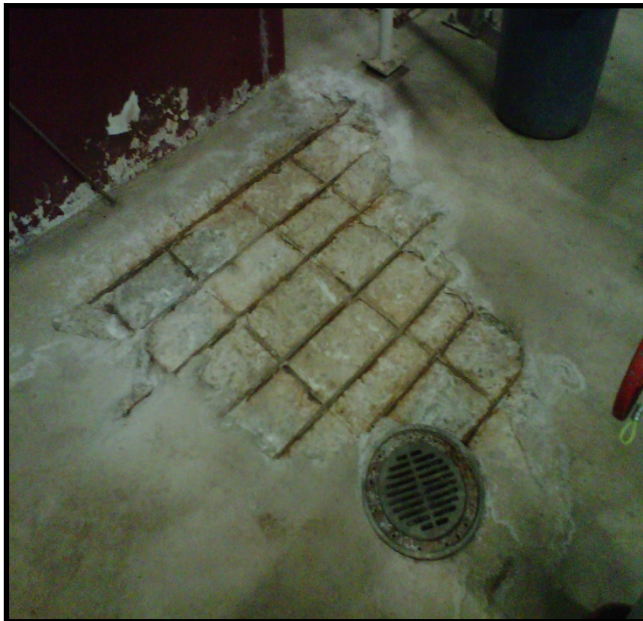
The floor in the power plant of a major beverage manufacturer was badly damaged from constant chemical attack.

The average depth of the damaged concrete floor was between 1" – 2". USI repaired the concrete with **USI Concrete Repair**, a high-performance repair compound, Concrete Repair 474, rebuilds and protects concrete while offering outstanding adhesion.

The repaired concrete was coated with **USI Epoxy Sealer**, a solvent free primer, and topped with **USI Ultimate Epoxy**. This coating is a two-component coating that provides excellent and lasting protection for concrete surfaces subjected to aggressive acids and chemicals.
