Project: Concrete Stairs Repair

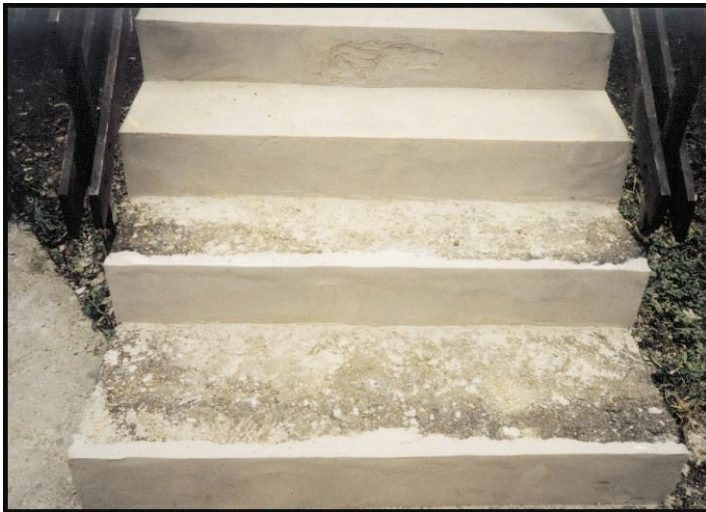
The project requirement was to completely repair and coat the stairway in this recreation area, which serves as a main access route.

A heavy-duty repair system was sought due to the "high wear" environment.

Cleaning and abrading of the surface of the repair area was completed before the application of a tack coat of **USI Concrete Repair Primer**. The damaged areas were then rebuilt using **USI Concrete Repair LW** which is a three component, solvent free, heavy duty epoxy repair mortar.

The entire surface of the concrete stairway was then coated with 3M Scotchkote Urethane Primer FB 856.

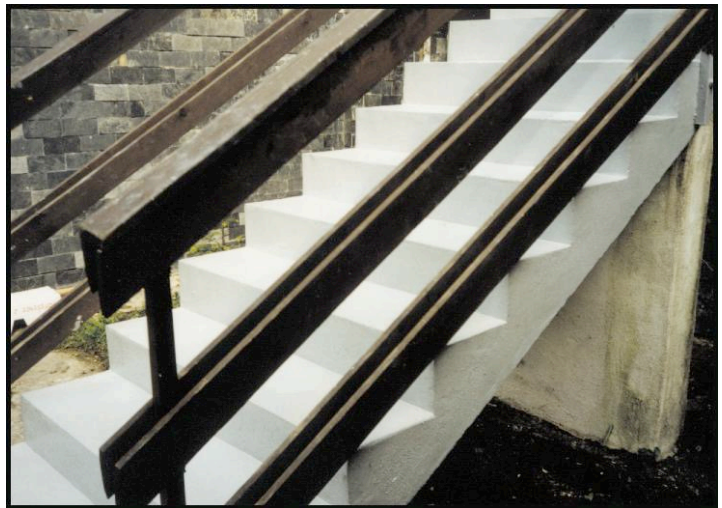
The stairs were no longer a safety hazard and the company was extremely satisfied with the quick and easy results.
