Project: Military Academy Stair Rebuild

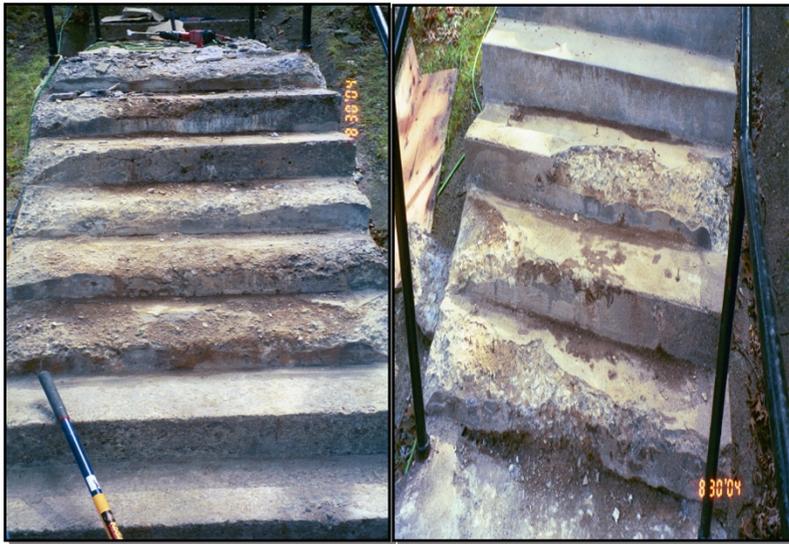
The project requirement was to completely repair and coat the stairway in this recreation area, which serves as a main access route. They wanted the project done in 30 days, with minimal damage to the surrounding foliage and minimal noise due to its location next to a hospital.

A heavy-duty repair system was sought due to the "high wear" environment.

The surface was cleaned and abraded before the application of a tack coat of **USI Epoxy Primer**. The damaged areas were then rebuilt **USI Quartz Screed** followed by **USI Concrete Repair LW**, which is a three component, solvent free, heavy duty epoxy repair mortar.

The entire surface of the concrete stairway was then coated with **USI Epoxy Sealer** followed **USI Epoxy Floor Coating**.

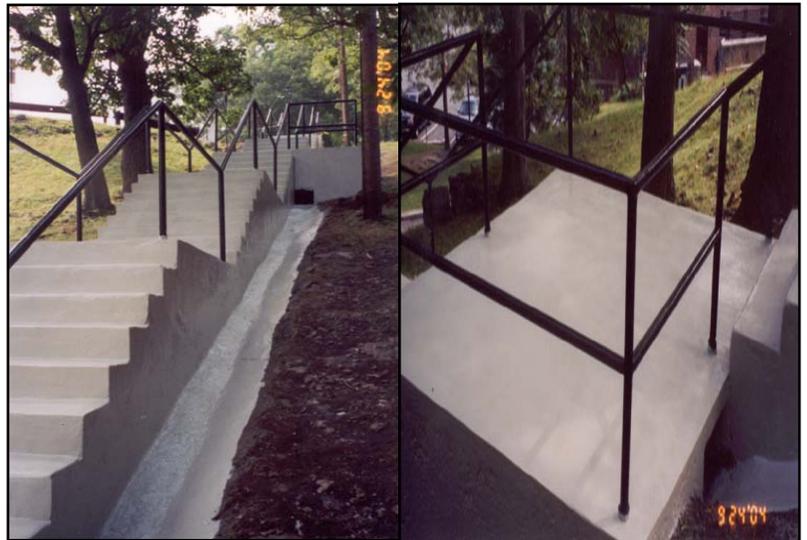
The stairs were no longer a safety hazard and the company was extremely satisfied with the quick and easy results.
