Emergency Pipe Leak Repair

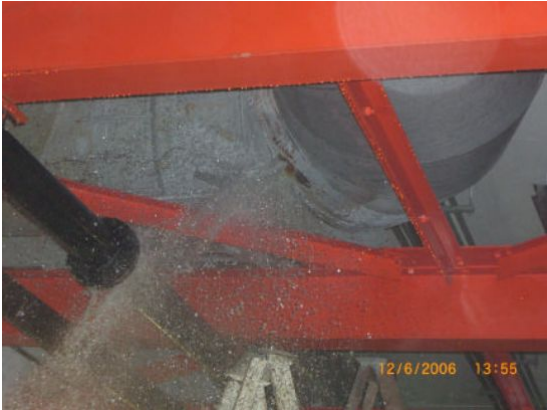
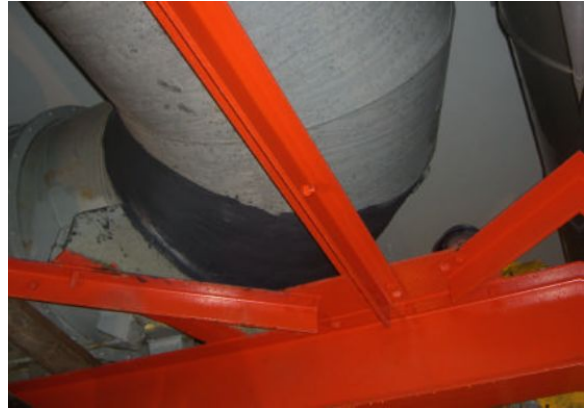
This 48in. suction piping for the return sludge pumps at a wastewater treatment plant had sprung this large leak and several smaller leaks.

Once the fluid source was cut off for pressure, the pipe surface was manually cleaned to an SSPC-SP10 finish. A form was manufactured to cover the leak area, and RESIMETAL 106 XF Metal Repair was used to fix it in place.

A reinforcing strap was used for added security, and 125 mils of RESIMETAL 101 Metal Repair Paste was applied. Reinforcing mesh was embedded into the product followed by 125 mils of RESIMETAL 101 Metal Repair Paste.

A 30-mil topcoat of RESIMETAL 202 Ceramic Repair Fluid was applied to protect the pipe against future impact and chemical damage.
