## Project: Nuclear Power Plant Pipe Repair

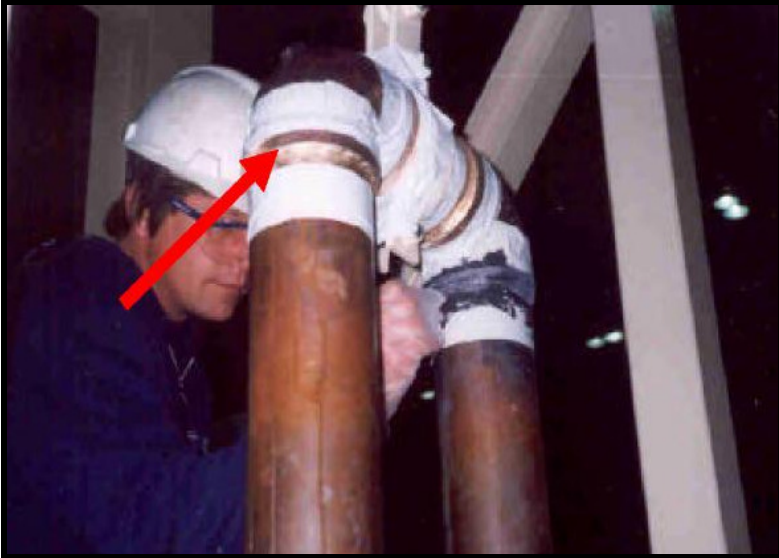
This nuclear power plant was getting diminishing UT readings for welds in their non-safety related pipe work.

The plant needed a solution to strengthen the pipe before a leak occurred. They called Unconventional Solutions to repair and protect the pipe work.

The pipe was abrasively cleaned at the joint weld, and then USI was able to repair the pipes by using **USI Urethane Metal Repair RG**. The area was taped off and 250 mils of **USI Urethane Metal Repair RG** were applied to reinforce the weld.
