Project: Floor Area Chemical Protection

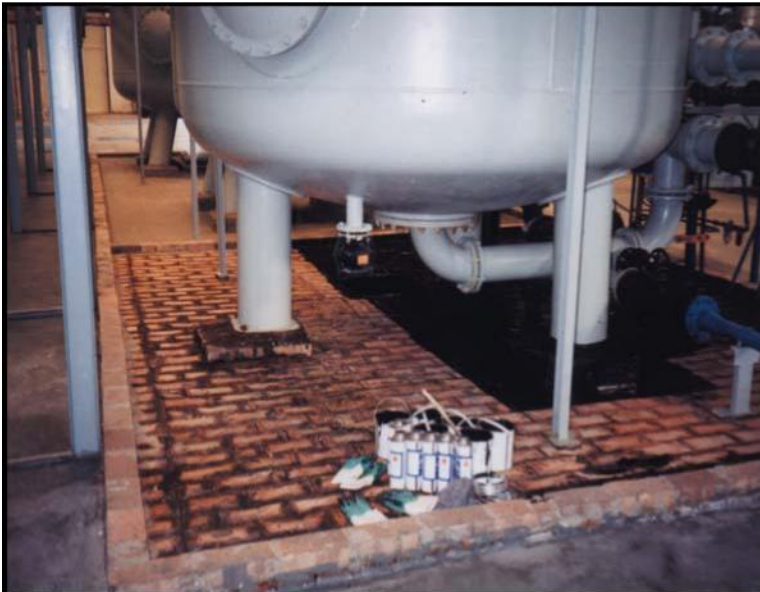
This floor area in a chemical factory was being attacked by acids from the processes used within the factory.

The floor was thoroughly abraded and cleaned.

One coat of **USI Epoxy Sealer SP** followed by two coats of **USI Epoxy Coating UC** was then applied. The system has provided excellent protection to the concrete and brickwork involved, and has proved to be the complete solution to the customer's problems.
