Project: Power Plant Warehouse Floor Restoration

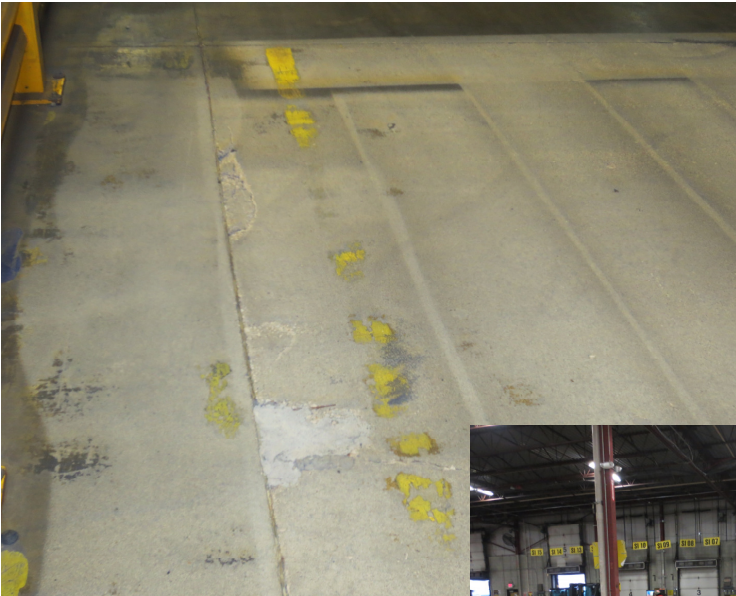
This warehouse floor was reaching the end of its life cycle and the client was looking for a way to refurbish it instead of tearing it up and pouring a new floor. This is the main warehouse that runs 24/7 for the utility company, so they are not able to close it down. Since Unconventional Solutions had had success with several other projects they selected our expertise and quality of service to do this job. They knew that if they

waited a couple more years, they would have to jackhammer the floor out and pour new. They were looking for a repair option to avoid the expensive replacement costs.
