Project: Treated Water Pipeline Leak Repair

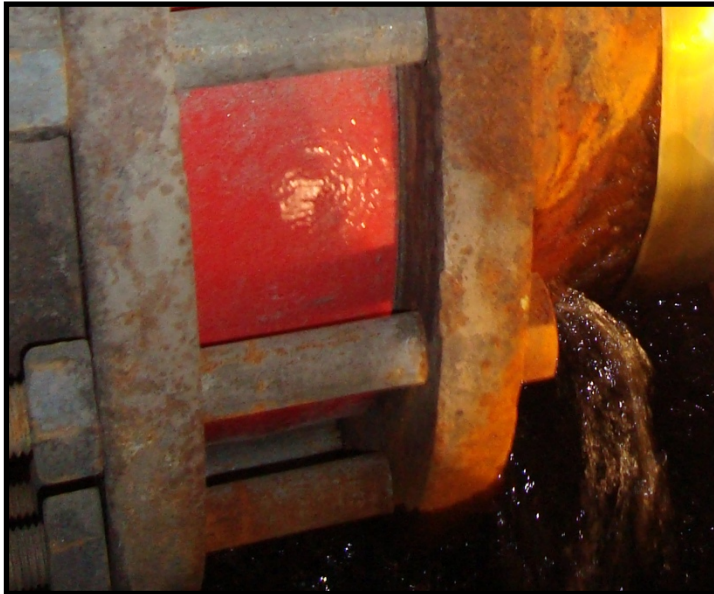
A steel mill was losing 50 to 70 gallons/minute on 10 inch chemically treated water pipeline. This leak was costing the plant almost \$4,000 a day in chemical treatment costs.

They attempted to use a mechanical clamp, but because of the nipple they were not able to get a tight seal and continued to lose water at very high rate.

Unconventional Solutions was able to accomplish this by using **USI Metal Repair SG** (Stick Grade) in conjunction with the larger size **Stop It** (4" x 12' or 4" x 25') pipe wrap to seal the leak in the pipe and bring the water loss to a stop.
