Compressor Station in Michigan #1

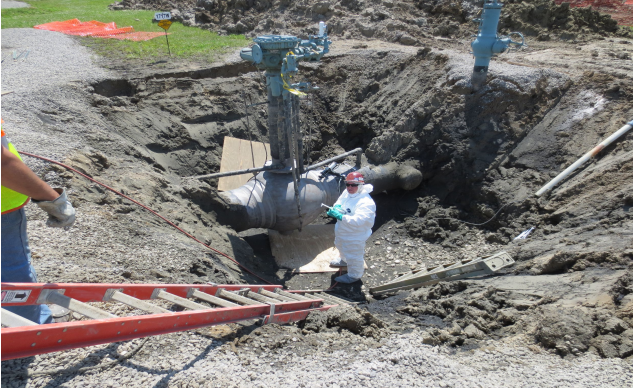
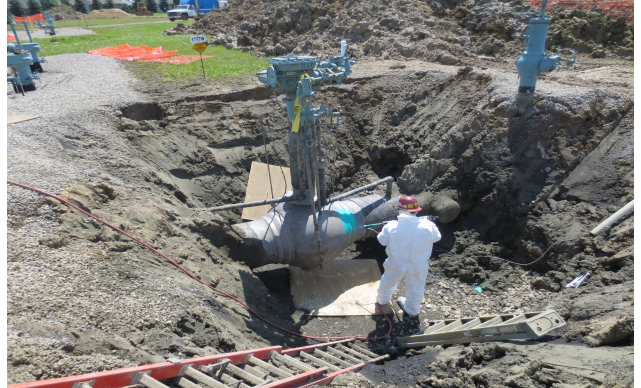
Some valves at a compressor station needed a new coating, as an alternative to coal tar.

The coal tar was grit blasted off to achieve a NACE #2 near white metal finish and a two-to-four-millimeter anchor pattern.

Next, [3M Scotchkote 323+ Spray System](#) was applied to save time and money. This resulted in fewer jeeps than the brush grade, which allows them to back fill quicker.
