## Project: Bag House Protection

### The Problem

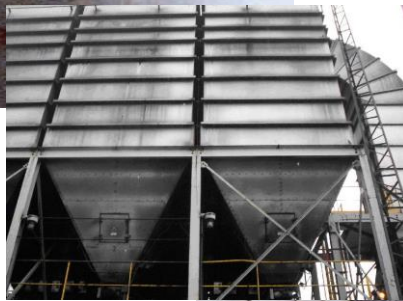
This Midwest Coke & Battery Plant was having problems with erosion and corrosion in their bag houses, causing small holes that constantly needed welding.

USI recommended the entire structure be water blasted to get rid of any salts or excessive corrosion. The small holes were repaired with **USI Urethane Metal Repair**, our 100% solid metal filled polymer repair system.

The entire structure was then coated with two 12 mil coats of **USI Epoxy Coating LV**. **USI Epoxy Coating LV** is a 100% solid, surface tolerant, corrosion protection system. It was selected due to the inability to sandblast the surface and the lower operating temperature.
