## Emergency Pipe Leak Repair

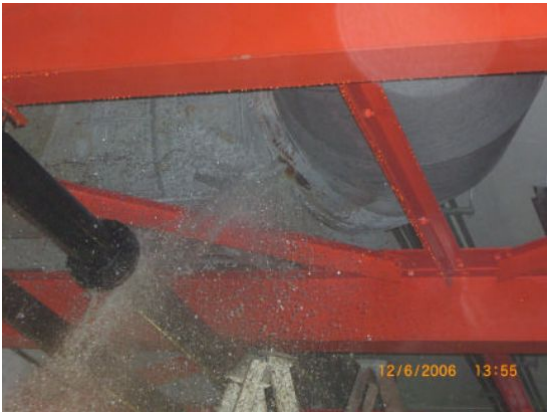
This 48in. suction piping for the return sludge pumps at a wastewater treatment plant had sprung this large leak and several smaller leaks.

Once the fluid source was shut off for pressure, the pipe surface was manually cleaned to an SSPC-SP10 finish. A form was manufactured to cover the leak area, and RESIMETAL 106 XF Metal Repair was used to fix it in place.

A reinforcing strap was used for added security, and 125 mils of RESIMETAL 101 Metal Repair Paste was applied. Reinforcing mesh was embedded into the product followed by 125 mils of RESIMETAL 101 Metal Repair Paste

A 30-mil topcoat of RESIMETAL 202 Ceramic Repair Fluid was applied to protect the pipe against future impact and chemical damage.

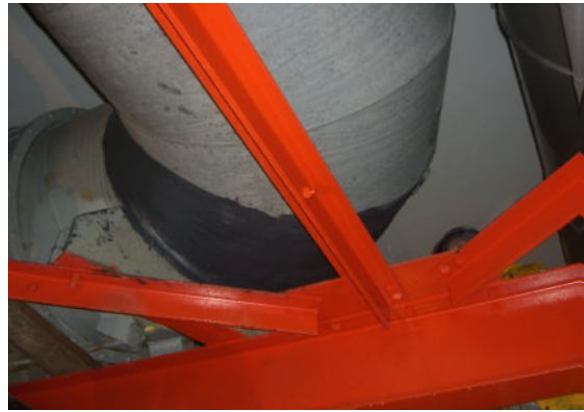
This repair has been in service for over 15 years now.
