## Project: Low Pressure Gas Leak Repair

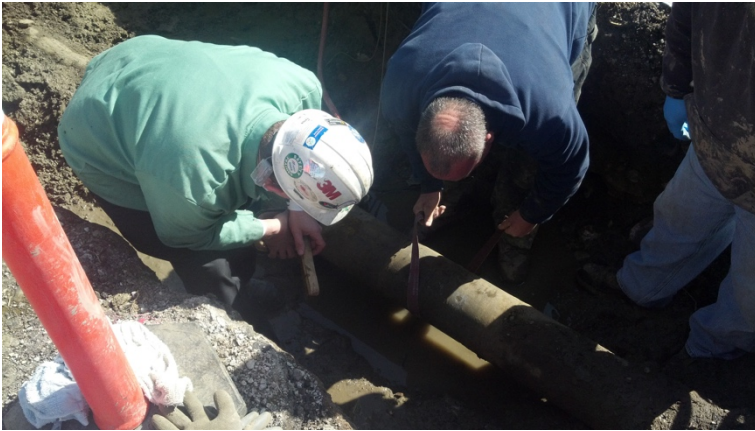
A local gas company in Ohio, after buying an existing distribution line, found out they had some small leaks.

This was a low pressure and low consequence area and they wanted an alternative to shutting down a major customer, while not sacrificing safety.

USI recommended using **USI 140 Self-Fusing Silicone Tape** along with **USI Water Activated Polyurethane Pipe Wrap**, which can handle up to 400 psi with 20 wraps and 150 psi with 15 wraps, and provided onsite training in the ditch, as you see in this Project Profile.

Before applying the **USI Water Activated Polyurethane Pipe Wrap**, the pipe was cleaned with **USI Universal Cleaner**, roughened with a hand tool, then cleaned once more with **USI Universal Cleaner**.
