Steel Mill Treated Water Pipeline Leak Repair

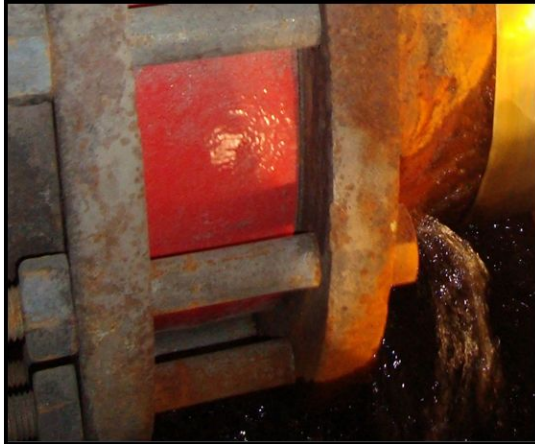
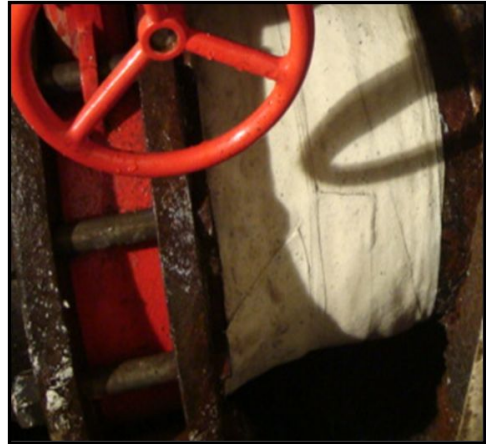
A steel mill was losing 50 to 70 gallons/minute on 10 inch chemically treated water pipeline. This leak was costing the plant almost \$4,000 a day in chemical treatment costs.

They attempted to use a mechanical clamp, but because of the nipple they were not able to get a tight seal and continued to lose water at very high rate.

Unconventional Solutions was able to accomplish this by using RESIMETAL 105 Aqua Stick in conjunction with RESIMETAL 108 Pipe Repair Tape to seal the leak in the pipe and bring the water loss to a stop.
