Success Story: Concrete Pipe Repair

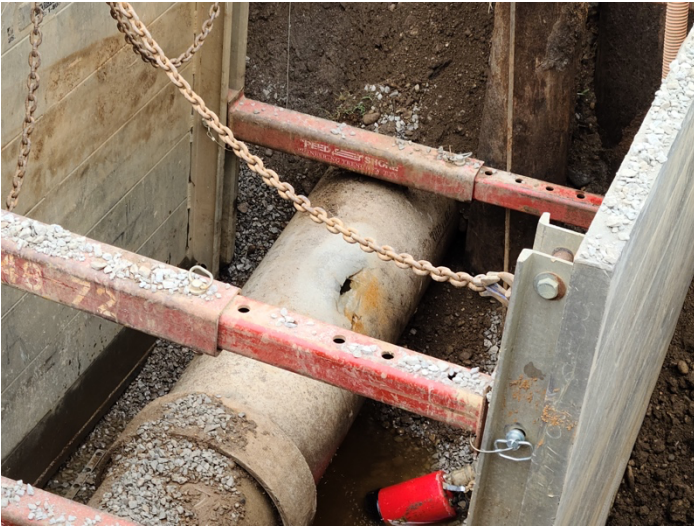
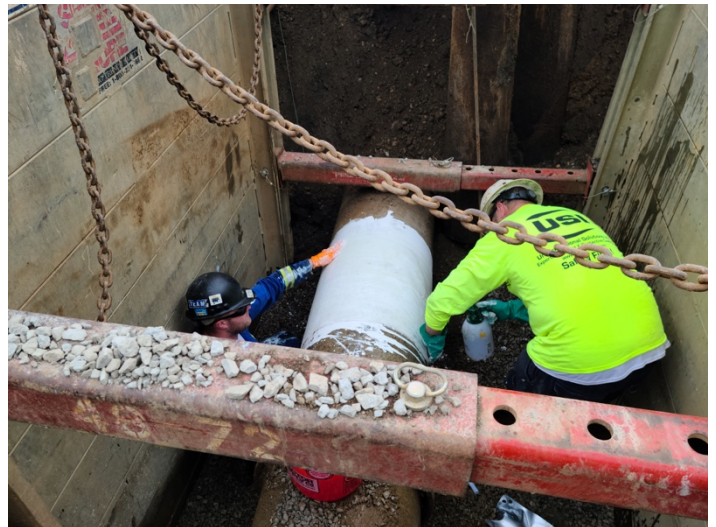
This Paper Mill had a Utility Company drill a hole into their 22" Asbestos Cement Transite Pipe. The Utility Company forgot to call 811 Miss Dig, and the result was the unwanted large hole in this Paper Mill's one of two main water pipes carrying the needed water into the mill to be able to operate properly. Had this Paper Mill not called Unconventional Solutions, Inc., it would have cost them between \$300,000 - \$400,000 in lost production, and downtime to replace the pipe using conventional methods, they needed another solution.

First **Resichem 574 Fastfill Plug** was applied. Fastfill Plug is a fast curing, water activated, reactive cementitious putty that works on concrete pipes and walls to stop any liquid seepage. Second, **Resichem 505 Damp Seal Primer** for wet concrete surfaces was applied to wet out fiberglass that was wrapped 6 ply's around the pipe. Third, **Resichem 501 CRS**, a high build epoxy coating that protects both steel and concrete against corrosion and chemical attack was applied. Lastly, 6 ply's of **Resimetal 108 Pipe Repair Tape**, a high performance, rapid curing, moisture activated pipe wrap, was applied to provide the needed PSI strength for a long term solution. The client was pleased with the results.
