Sand Filter Repair

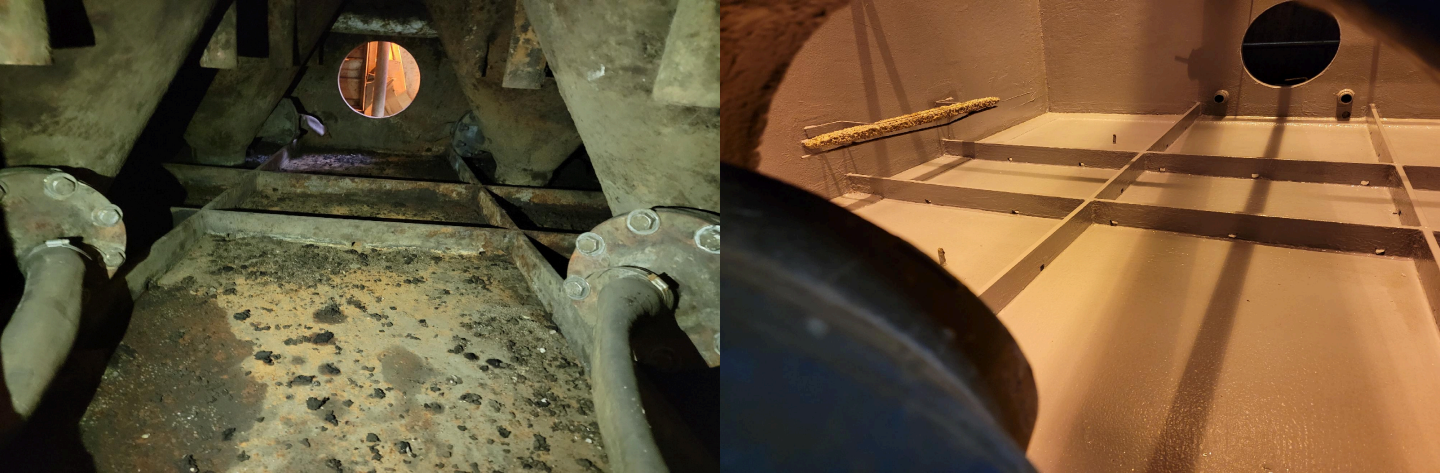
This steel mill was experiencing leaks in their sand filter and replacement costs were going to run into the millions of dollars. When you consider removal of old sand filters, the price of new sand filters, and installation costs a long-lasting repair is a better option.

This particular steel mill had Unconventional Solutions, Inc. partner up with one of their on-site contractors to train and provide technical support and troubleshooting on how to use [RESIMETAL 101 Metal Repair Paste](#) for holes and pitting. Then 2 coats, 1 of [RESIMETAL 202 Ceramic Repair Fluid](#) in blue and 1 of [RESIMETAL 202 Ceramic Repair Fluid](#) in light gray, were applied for abrasion and erosion protection.
