## Crude Oil Pit Rebuild and Protection

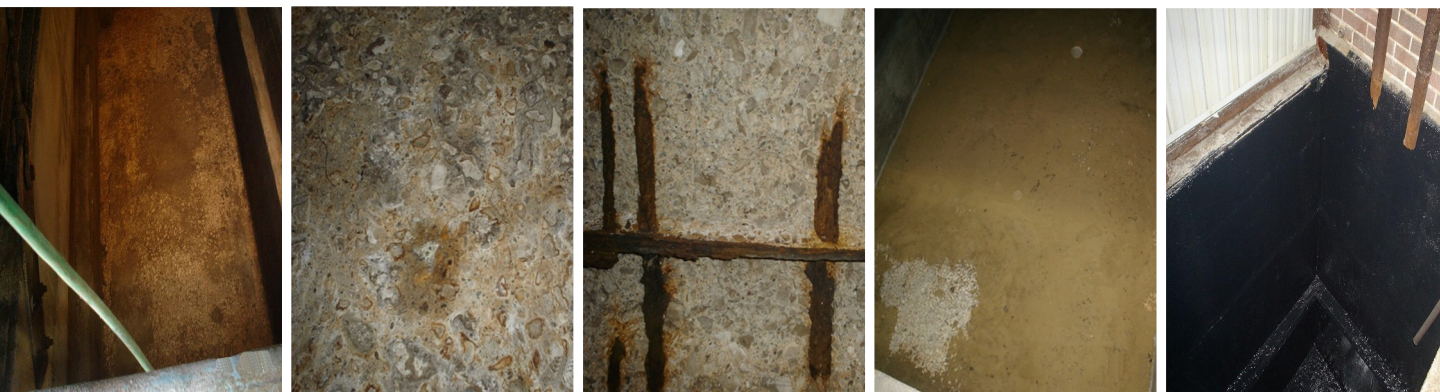
This old crude oil pit was severely decayed.

To accommodate the customer's request, Unconventional Solutions suggested the use of pea gravel and 1/2 clean sand as well as [RESICHEM 503 SPEP](#) to get a bulk fill.

[RESICHEM 503 SPEP](#) was used to coat the existing concrete before using two coats of [RESICHEM 511](#) epoxy coating was used to protect the pit from the crude oil along with anything else which may come in contact with the pit.
