Chemical Plant Concrete Flooring Repair

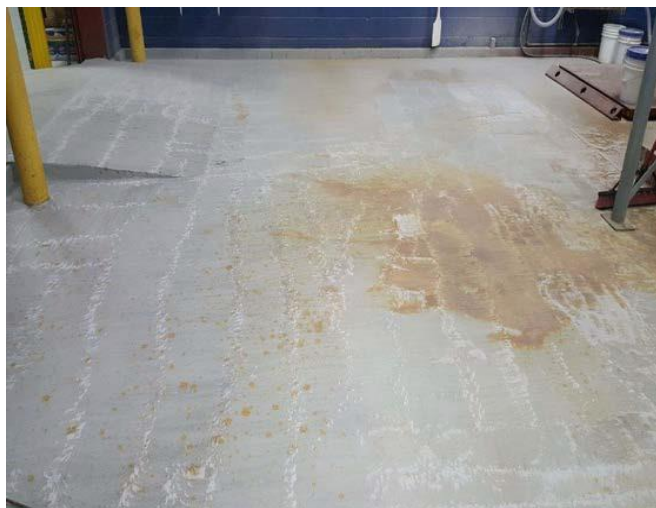
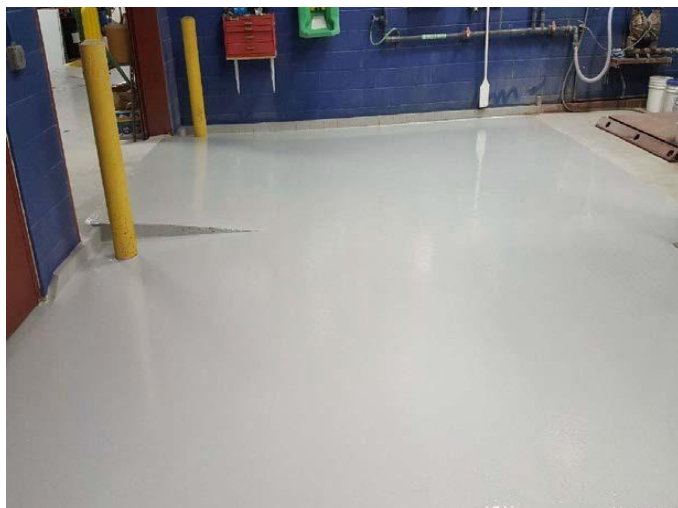
A chemical plant was seeing aggressive chemical attack on their floor. The customer had a cocktail of different chemicals that could be present at any given moment so they needed a durable, multi-purpose solution that could provide long-term protection.

The most important step of the project was to use a shot blaster with a vacuum on the back to pick up all the contaminated old debris.

The next step was to apply [Duromar DF-1303 Zero VOC Concrete Sealer](#) to prime the surface.

After that we applied two coats of [Duromar HPL-4320](#) in alternating colors. This product was chosen because it is a Novolac that provides excellent chemical resistance.
