Containment Area Repair

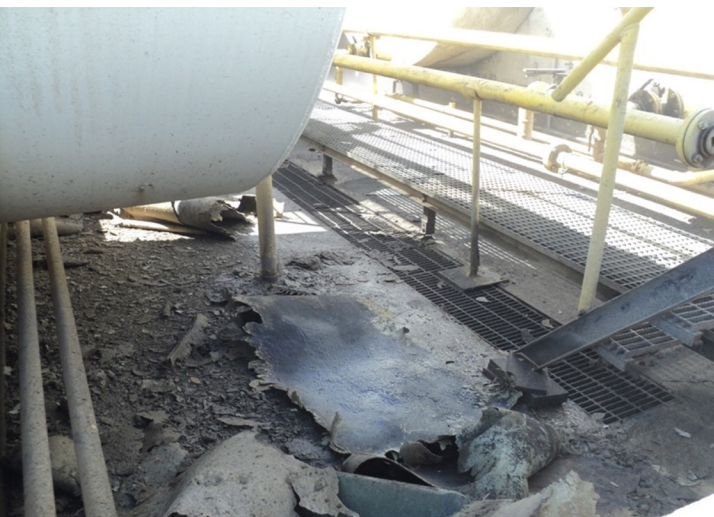
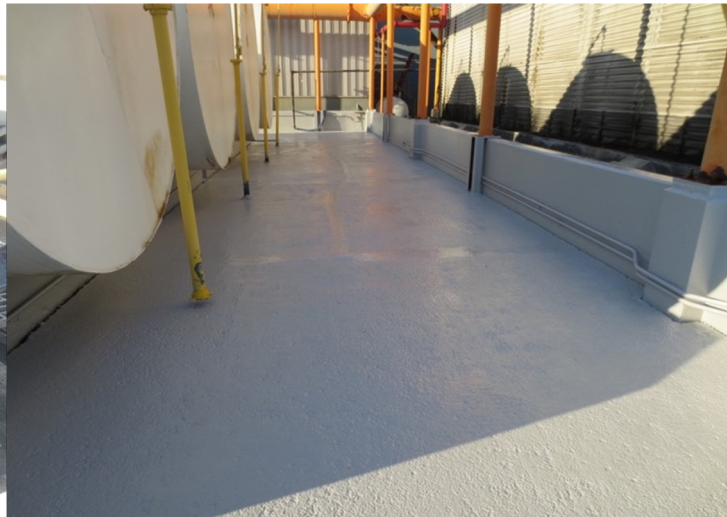
The EPA was about to fine this truck diesel repair for the condition of their secondary containment. Unconventional Solutions was called in to save the day!

USI repaired the concrete lining, which includes the floors and walls.

[RESICHEM 576 Quartz Screed](#) was used to rebuild the floor and [RESICHEM 571 Concrete Repair LW](#) was used to rebuild the vertical surfaces on the walls.

After repairing the concrete, we primed the area with [RESICHEM 503 SPEP](#) and sealed it with [RESICHEM 511 UCEN](#) for chemical resistance.
