## Wastewater East Drainpipe Repair

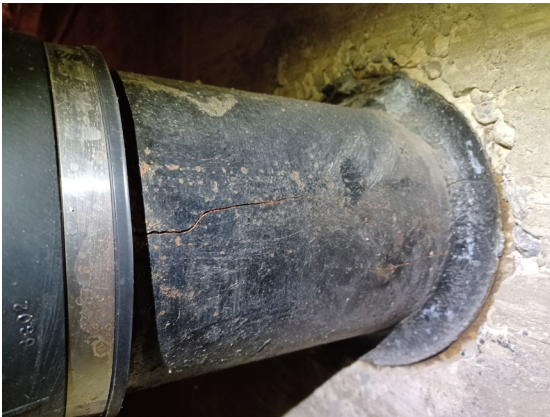
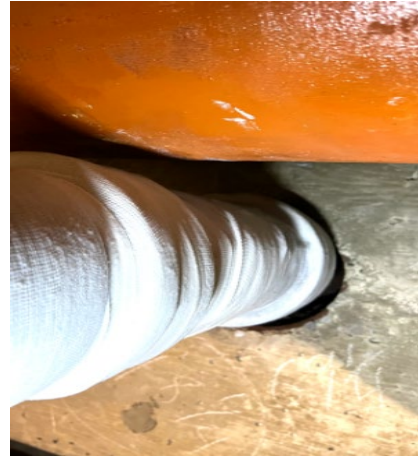
A school was experiencing issues with a wastewater drainpipe that had multiple holes and cracks. The damaged pipe was also causing a foul odor in the basement. The client contacted Unconventional Solutions to seal the holes and protect the pipe from future corrosion.

Surface preparation involved wire brushing followed by the application of [USI Universal Cleaner](#).

Once the surface was properly cleaned, the [Resimetal 103 Metal Repair Stick](#) was applied to the areas with holes to effectively seal them.

Next, the [Resimetal 108 Pipe Repair Tape](#) was applied over the entire cracked area.
