Wastewater West Drainpipe Repair

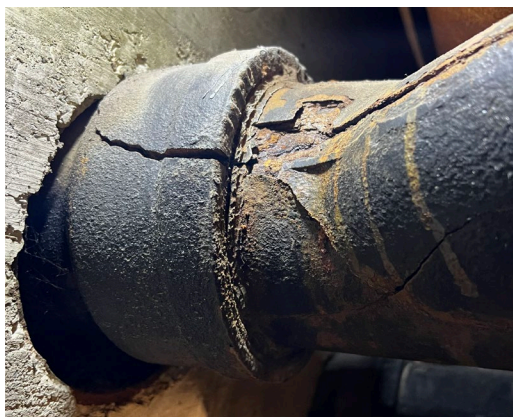
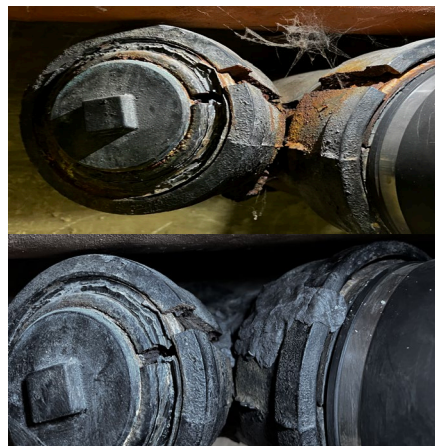
A school had a wastewater drainpipe that had multiple holes and cracks in the pipe. The pipe was also producing a foul smell in the basement. The client contacted Unconventional Solutions to seal the holes and protect the pipe from future corrosion.

Surface preparation involved wire brushing followed by the application of [USI Universal Cleaner](#). Once the surface was properly cleaned, The [Resimetal 103 Repair Stick](#) was applied to the areas with holes to effectively seal them.

Next, the [Resimetal 108 Pipe Repair Tape](#) was applied over the entire cracked area. To achieve different psi, bandage requirements are as follows: 50psi – 10 wraps minimum, 150psi – 15 wraps minimum, 400psi – 20 wraps minimum.
