Low Pressure Gas Leak Repair

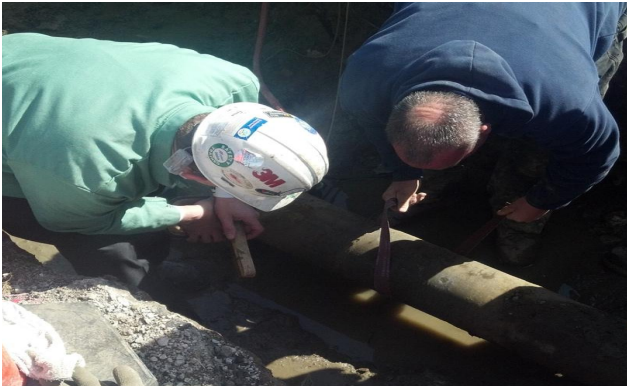
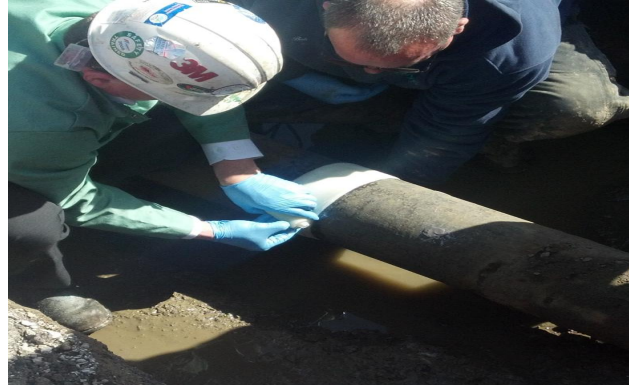
After buying an existing distribution line, a local gas company in Ohio found out they had some small leaks.

This was a low pressure and low consequence area, and they wanted an alternative to shutting down a major customer, while not sacrificing safety.

Unconventional Solutions recommended using [330 Self-Fusing Silicone Tape](#) along with [RESIMETAL 108 Pipe Repair Tape](#). This Resimac tape can handle up to 400 psi with twenty wraps and 150 psi with fifteen wraps. USI also provided onsite training in the ditch as you can see in this project profile.

Before applying the [RESIMETAL 108 Pipe Repair Tape](#), the pipe was cleaned with [USI Universal Cleaner](#), roughened with a hand tool, and the cleaned once more with [USI Universal Cleaner](#).
