## Truck Island Concrete Repair and Protection

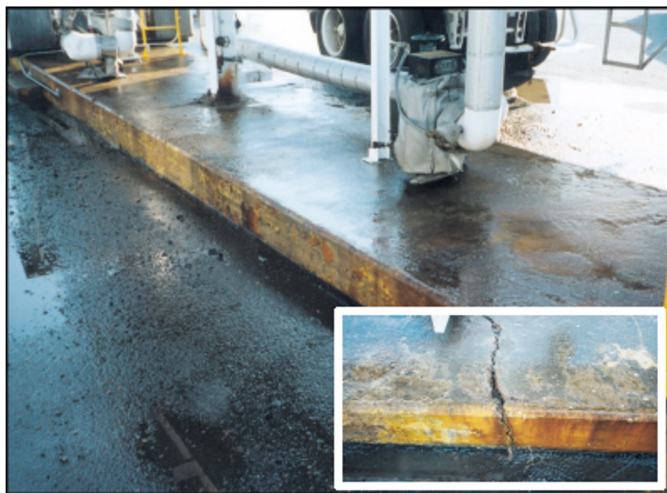
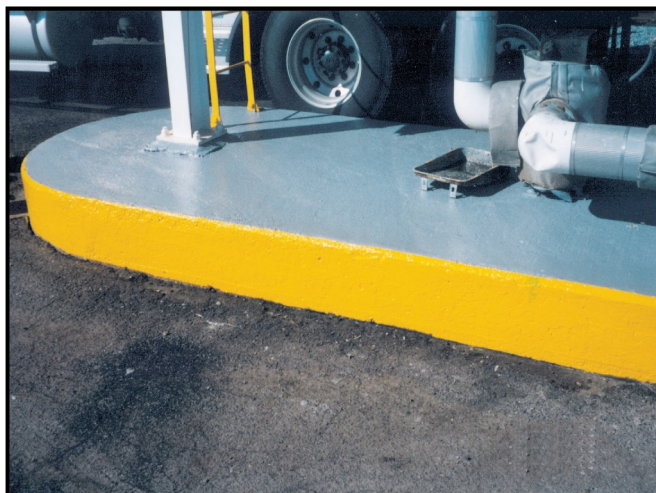
The photographs show the badly damaged concrete surfaces of a truck island which is part of this refinery's large truck unloading area.

The corroded metal was blasted and primed with [Resichem 506 AluPrime](#).

The damaged concrete was repaired using our solvent-free epoxy resurfacing product, [Resichem 576 Quartz Screed](#).

Then the entire concrete surface was prime with [Resichem 503 SPEP](#).

[Resichem 511 UCEN](#) was then applied in two coats over both surfaces to provide outstanding chemical, corrosion, and abrasion resistance.

[USI Granular Aggregate LD](#) was back-rolled into the top layer of [Resichem 511 UCEN](#) on the edges of the truck islands and the areas adjacent to the islands to provide a slip-resistant surface.
