St. Clair Floor Repair

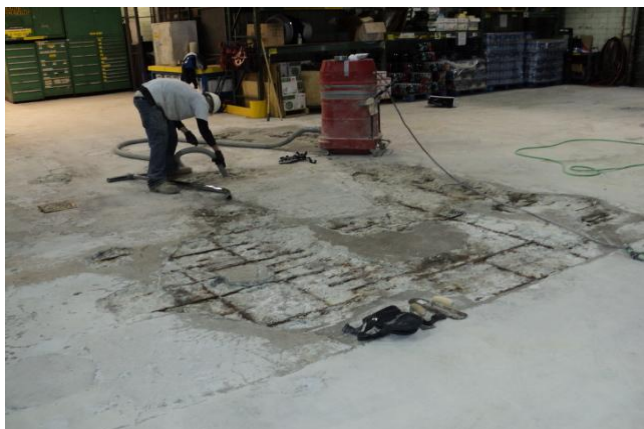
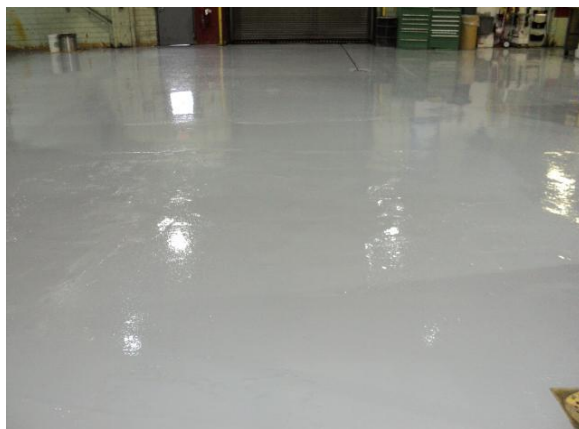
This major great lakes power plant was experiencing “trips and falls” hazards in their warehouse. Employees were going in and out and the concrete was over fifty plus years old. It had started to crumble in many spots, and they did not have time to cut out and pour new cement.

The challenge was that the rebar had corrosion on it that made the concrete break apart. To solve this, [RESICHEM 506 Aluprime](#) was used to coat the rebar.

[RESICHEM 576 Quartz Screed](#) to rebuild the damaged concrete areas.

[USI High Build Floor Epoxy](#) was used to give it a safe and easy to clean surface after back-rolling with [USI LD Grip Granular Aggregate](#). This system helped eliminate the #1 OSHA reportable “Trips & Falls”.
