## Pump Refurbishment

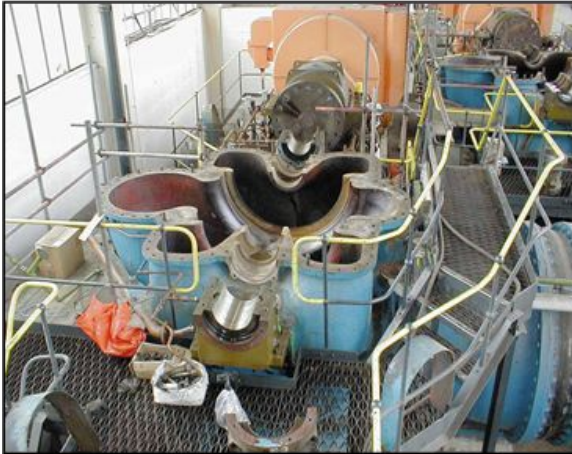
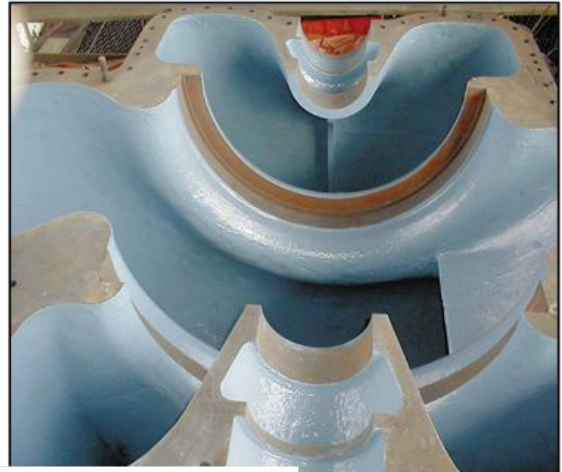
A cold-water pump at a coal-fired power station had been earmarked for refurbishment after a routine maintenance inspection due to heavy “wear and tear” that it had been subjected to over many years of use.

The surfaces of the pump to be coated were abrasive blast cleaned to a minimum industry standard of NACE Grade 2 prior to the application of two coats of our solvent free ceramic epoxy coating.

RESIMETAL 202 Ceramic Repair Fluid in contrasting colors grey and blue was applied to ensure thorough application and complete coverage.
