Foyer at a Refinery

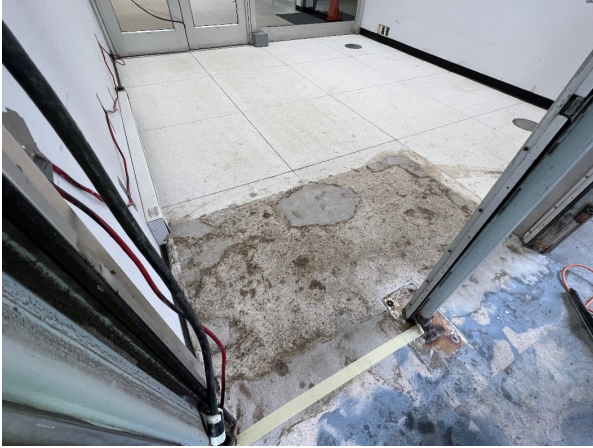
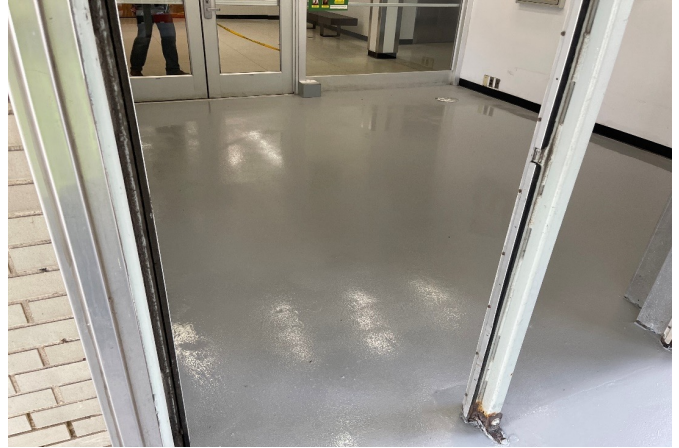
This client had concrete steps and entryways into the buildings that needed some type of coating that would be more durable than just some paint as what was on there was failing and in need of removal and replacement.

He went on to explain that improving safety is one of the main concerns for wanting to get the steps re-done and was looking for some non-skid characteristics.

USI removed the coating with a stand behind diamond grinder. Prep was completed by roughing up the tiles and cleaning out the patch areas that were failing.

We repaired the surfaces that had failed with the [USI Epoxy Mortar Patch Kit](#). The next day the [USI Flexible Broadcast Primer](#) was applied, we waited until 8 hours and then applied one coat of [USI Moisture Curing Polyurethane Color Coating](#).

On the third day the second coat of [USI Moisture Curing Polyurethane Color Coating](#) was applied by adding [White Aluminum Oxide](#) back rolled into the coating.
