## Compressed Air Pipe

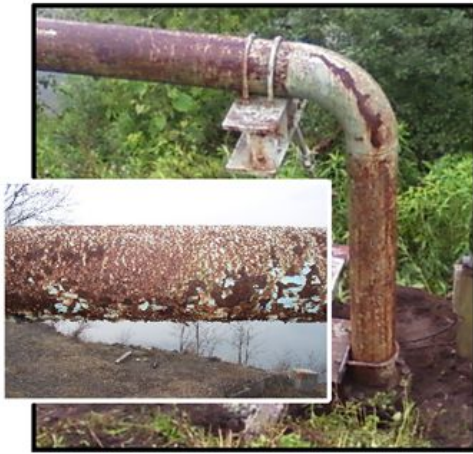
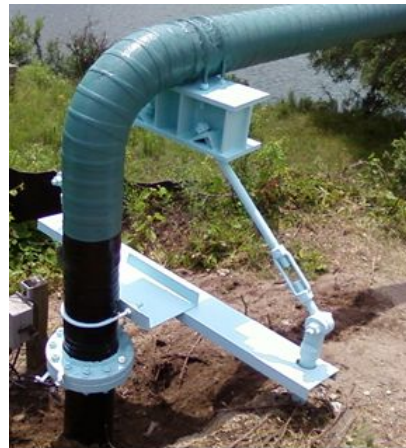
A company that supplies atmospheric and specialty gases to a wide range of industries including aerospace, chemical, oil, gas, refining, and other areas of general industry was experiencing heavy corrosion on a compressed air pipe.

First, 200 feet of pipe was hand scraped and abraded to remove flaking paint. The pipe was wrapped with Viscotag E-Z Wrap, a paintable 70 mil tape that provides immediate adhesion, is a-polar, rejects water, and requires no cure time. The pipe was then painted in the company's signature color.

At the soil to air transition the pipe again was hand scraped and abraded. Denso Glass Outerwrap was applied to the pipe from the flange to the yellow jacket (about 7ft).

All pipe supports were coated in Resichem 555 Resinox, a single component, water-based, anti-corrosive coating.
