## Training and Troubleshooting Tank Farm Fuel Lines

### PROBLEM

USI's AMPP Coating Inspector was called on site to help train, troubleshoot, and problem solve with a contractor.

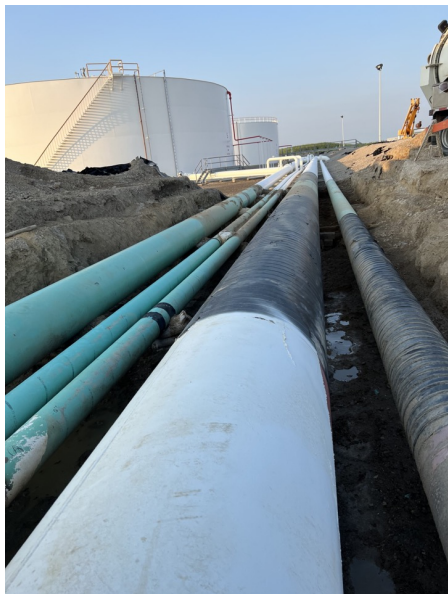
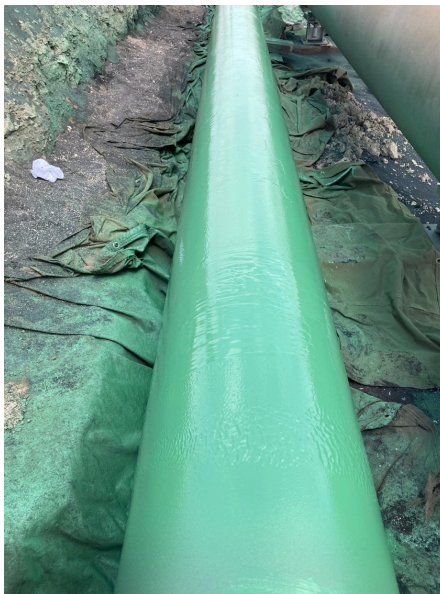
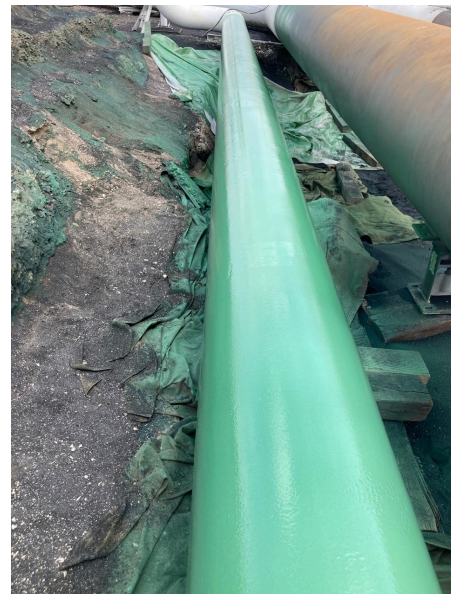
This tank farm had airport jet fuel lines that were coated with multiple types of coatings from white atmospheric paint, to PVC or utility tape, to a mastic coating, and a yellow hard plastic coating.

The next challenge was the various sizes of pipe and different ways to coat them. The pipes ranged from 4 inches in diameter all the way up to 36 inches in diameter.

After using the different methods of removal, the contractor abrasive blasted the lines and used the [Denso Protal 7200 Spray Grade 1,000ml Cartridges](#) on the larger diameter pipes. The smaller diameter pipe needed to be brushed or rolled on with the [Denso Protal 7200 Brush Grade 1L Kits](#).
