Leading Edge

JUNE 2024 | WWW.USIGROUPS.COM

Rescuing a Truck Diesel Repair Shop from EPA Fines with Effective Concrete Secondary Containment Repair

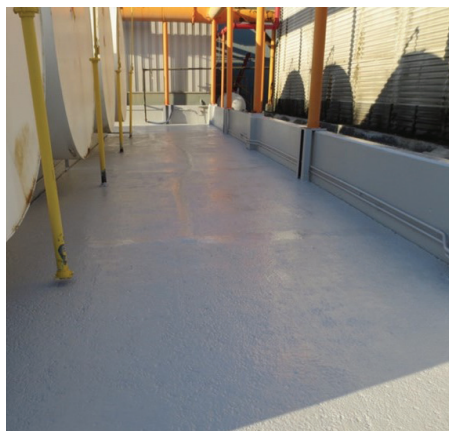
A truck diesel repair shop was on the brink of facing fines from the Environmental Protection Agency (EPA) due to the deteriorating condition of their secondary containment area what they needed secondary containment concrete repair. Recognizing the urgency of the situation, Unconventional Solutions was called upon to provide a timely and effective solution to bring the containment area up to compliance standards.

The area in need of repair was primarily constructed of concrete, including both the floors and the walls of the secondary containment. Concrete, while durable, can deteriorate over time, especially in industrial settings with exposure to harsh chemicals and heavy wear. Unconventional Solutions implemented a comprehensive repair strategy, focusing on both the structural integrity and chemical resistance of the containment area.

Concrete Lining Repair: The team began by repairing the concrete lining of the containment area. This involved rebuilding the floor using **RESICHEM 576 Quartz Screed**. The vertical surfaces on the walls were rebuilt using **RESICHEM 571 Concrete Repair LW**.

Priming and Sealing: After the structural repairs were completed, the area was primed with **RESICHEM 503 SPEP** and sealed with **RESICHEM 511 UCEN**.
