Paper Mill Pipe Repair

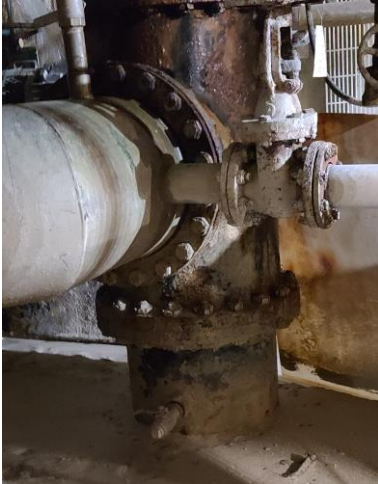
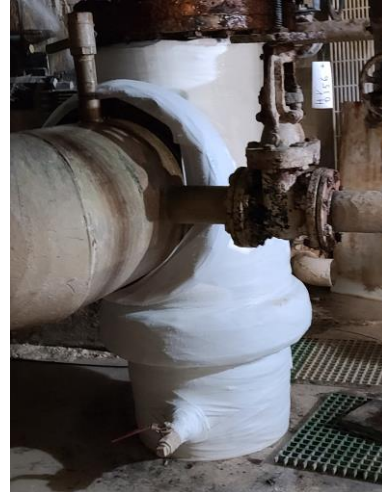
The Paper Mill Plant faced a critical issue with leaking, corroded, and eroded steel pipes. These pipes were impossible to replace without causing a major forced outage at the mill. The plant required an effective solution to extend the life of these pipes and avoid the significant disruptions and costs associated with pipe replacement.

Surface Preparation: The area was cleaned and prepped according to the Technical Data Sheet for the selected products. Proper preparation ensured optimal adhesion and effectiveness of the repair materials.

[Resimetal 103 Metal Repair Stick](#) was applied to any holes or areas where the pipe wall had thinned. This product provided an immediate and effective repair to restore the pipe's integrity.

Application of Pipe Repair Tape: Following the application of the repair stick, [Resimetal 108 Pipe Repair Tape](#) was applied according to its Technical Data Sheet. This moisture-activated tape cures fully in 30 minutes with no shrinkage and can withstand operating temperatures up to 270°C. The high psi rating of up to 750 psi (50 bar) ensures robust and durable repairs.
