## Gutter Repair & Waterproofing

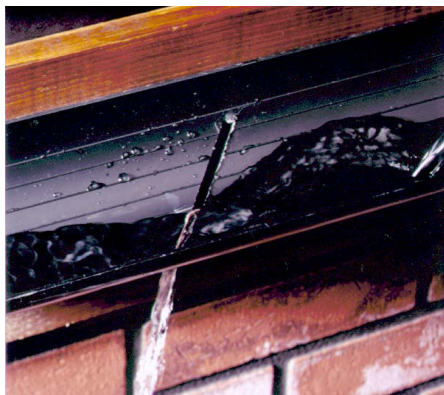
This gutter had been cut all the way through and was leaking very badly.

**Resimac ResiChem 551 ER Membrane** was used to make the repair.
