Wastewater Plant 54” Pipe Repair

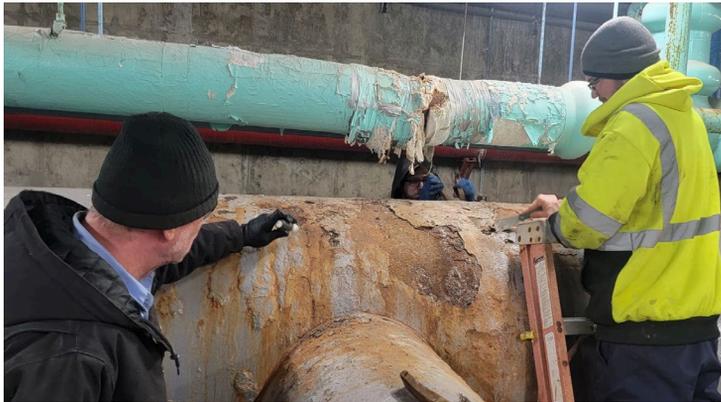
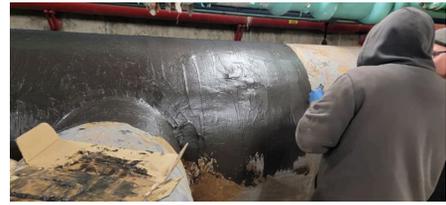
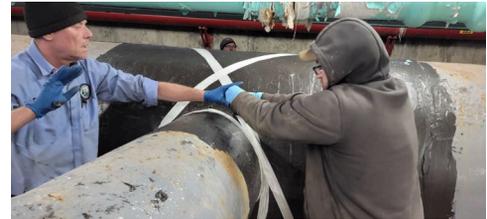
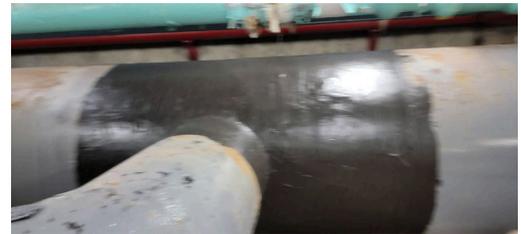
A city wastewater plant in Michigan needed to protect their pipe before the wall thickness became too thin and they were forced to replace. This would have been extremely challenging and would have been \$100,000's+ to remove the old pipe and install a new pipe.

Unconventional Solutions came in and trained the wastewater employees on how to make a fiberglass pipe around a pipe. The project only required roughly \$ 20,000 in materials to repair and upgrade the piping for an additional 10+ years of service and potentially longer.

Surface preparation was completed with a solvent cleaner and wire brush to remove all existing loose rust and coating. **Resimac 302 Epoxy Repair Cement** was used as a surface tolerant. Then **Resimac 703 Glass Tape** was used with **Resimac 301 Epoxy Resin** which produced a high strength composite repair.
