# CASE STUDY

## 36" Pipe Refurbishment

Water & Wastewater

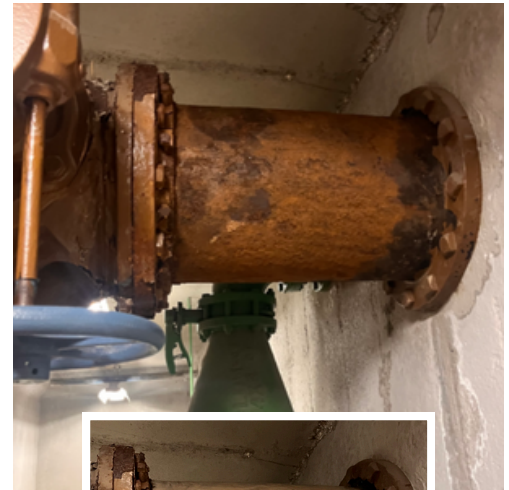
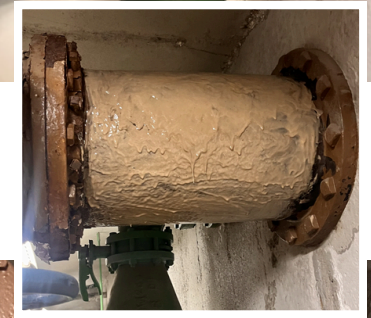
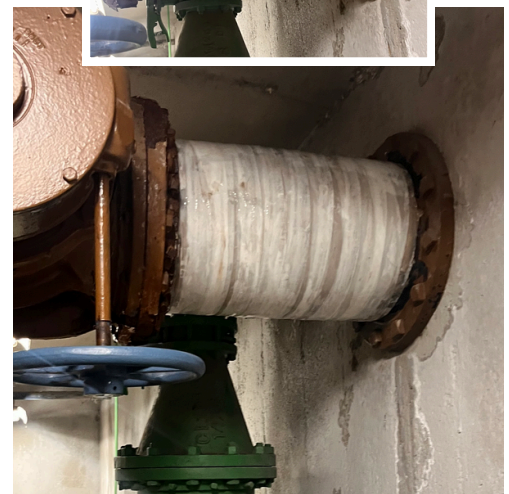
This wastewater treatment plant had a 36-inch pipe that was severely corroded.

First, the loose rust and debris was removed from the pipe. An MBX Bristle Blaster was then used to prepare the surface.

Once an acceptable surface profile was achieved, the area was cleaned and degreased using USI Universal Cleaner.

Resimetal 302 was used to rebuild the metal loss, followed by Resimetal 301 and Resimac Reinforcement Tape 807. A final layer of Resimetal 301 was then applied.
