CASE STUDY

48" Pipe Refurbishment

Water & Wastewater

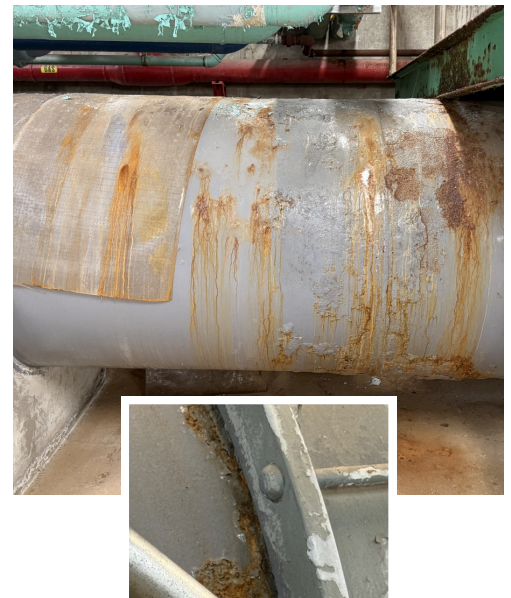
The client identified severe corrosion on a 48" ductile iron pipe caused by H₂S exposure.

Given that the plant was built in 1956 and the pipe is located in the basement, replacing it would be both complex and costly. To avoid the risk of a rupture, they opted not to pursue full pipe replacement and instead repair the pipe.
